Hall Engineering Inspections, Ltd.

# Property Condition Report

*Professionally Prepared For:*  
*Community Health Centers*  
*1701 Harrison*  
*Little Rock, AR*

*Property Information:*  
*Purpose: School*

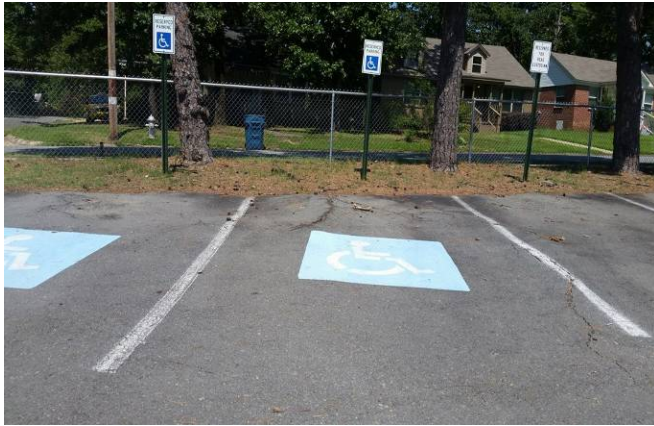
3. Asphalt parking surface weathered. Stripes fading, need to be repainted. Tree roots causing some damage along W edge of parking lot.
4. Water ponding in several places on E side of lot in playground area.

Parking lot wear

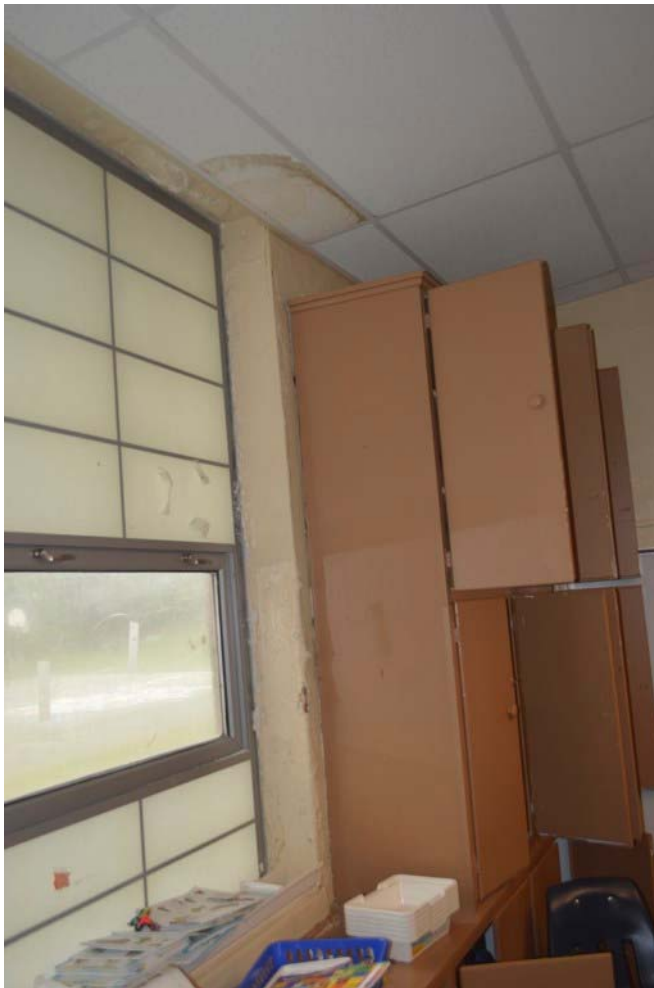
Roof leaks

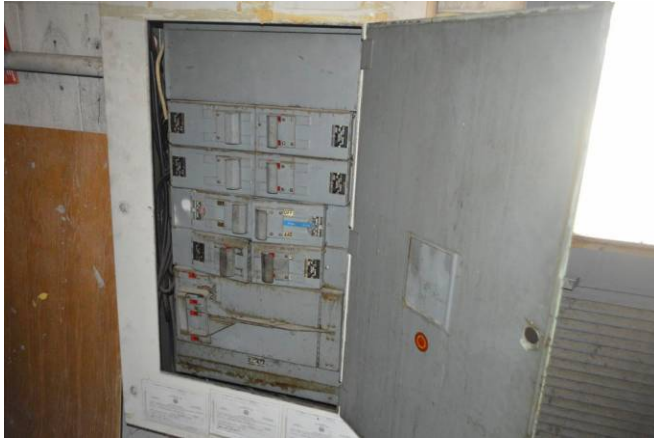
1. Several original fuse boxes remain installed. Suggest update to modern circuit breaker panels.

Older electrical panel box

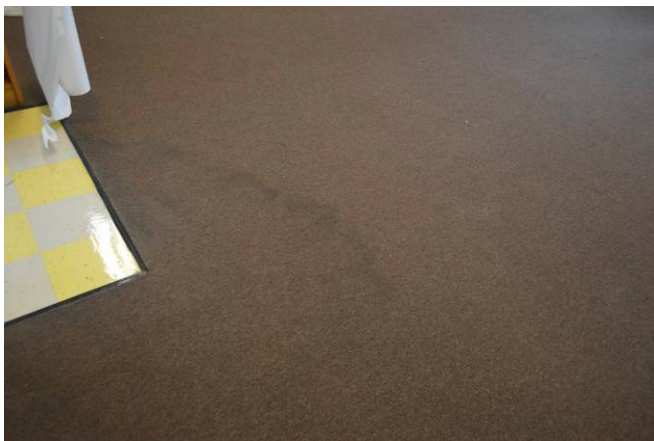
Water damage

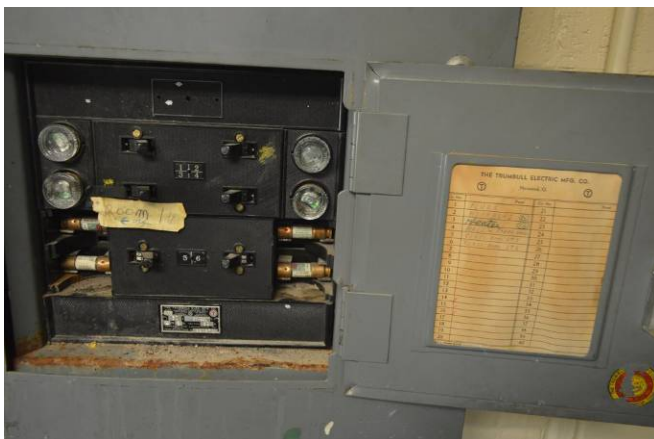
Older electrical panel box

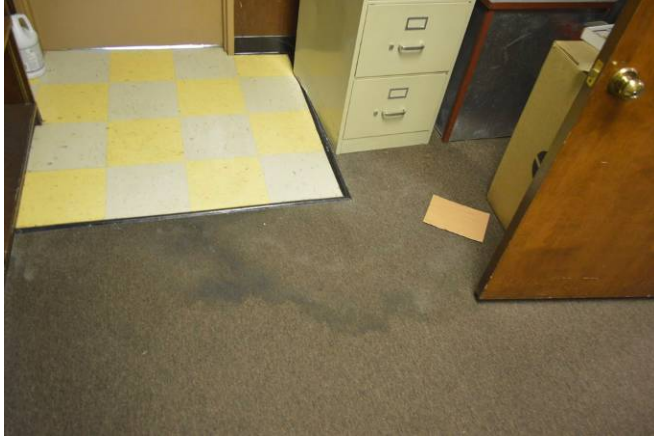
More water stains

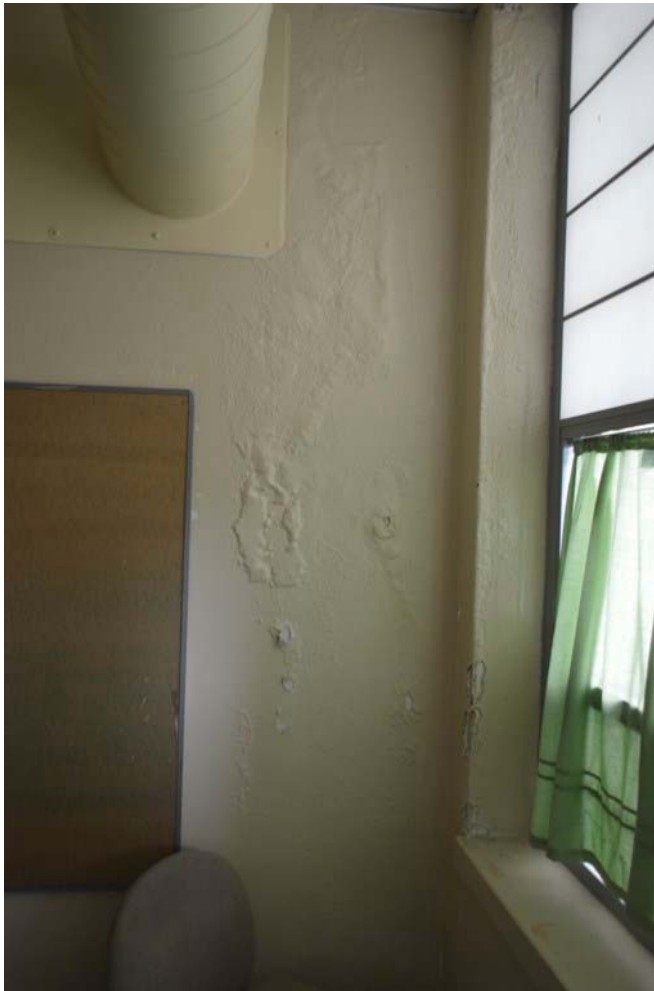
Water damage

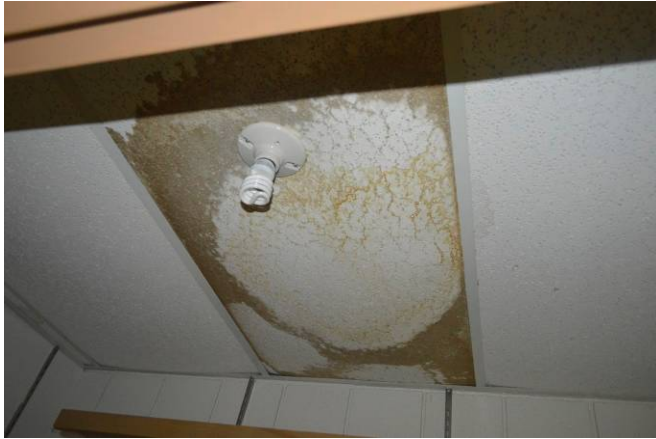
Water damage

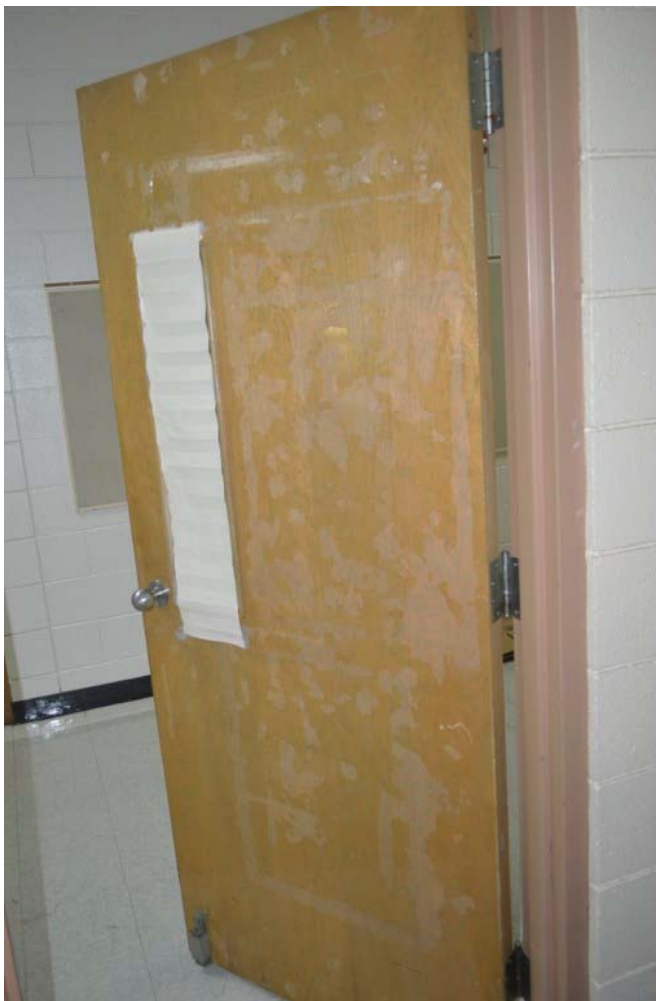
Door surface damage example

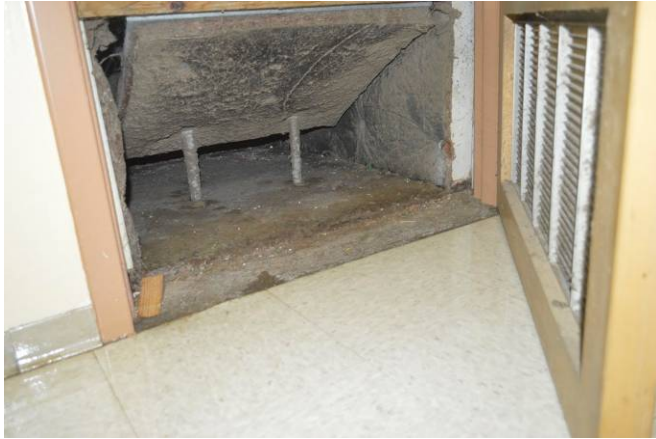
Flue rust and soot

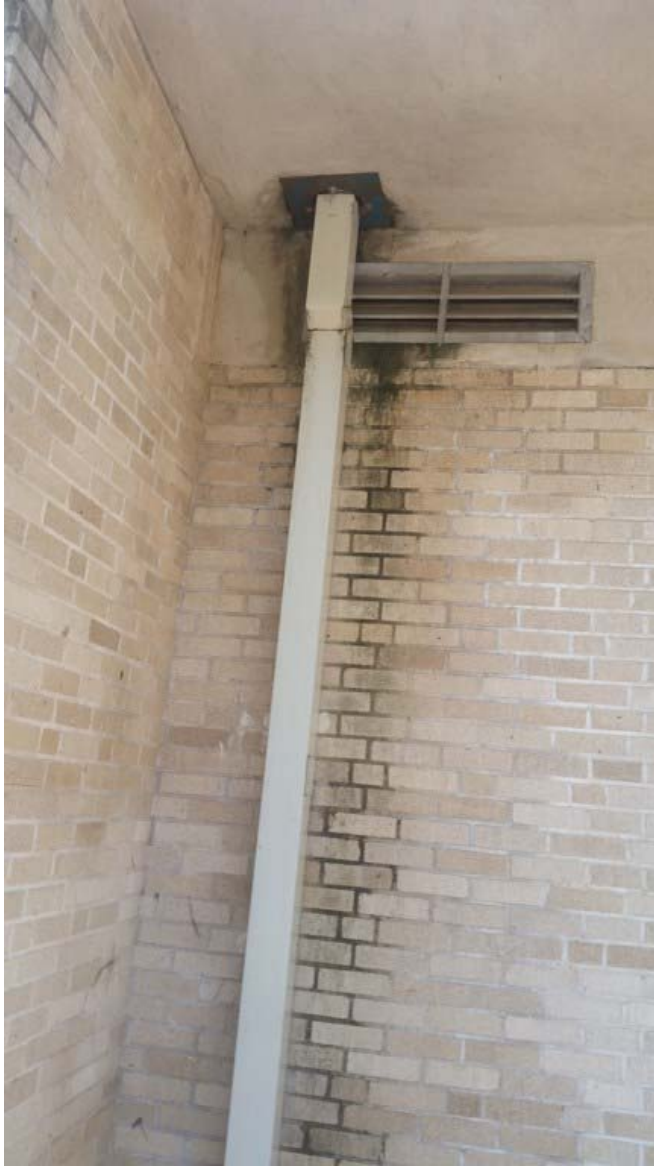
Roof leaks at gutters

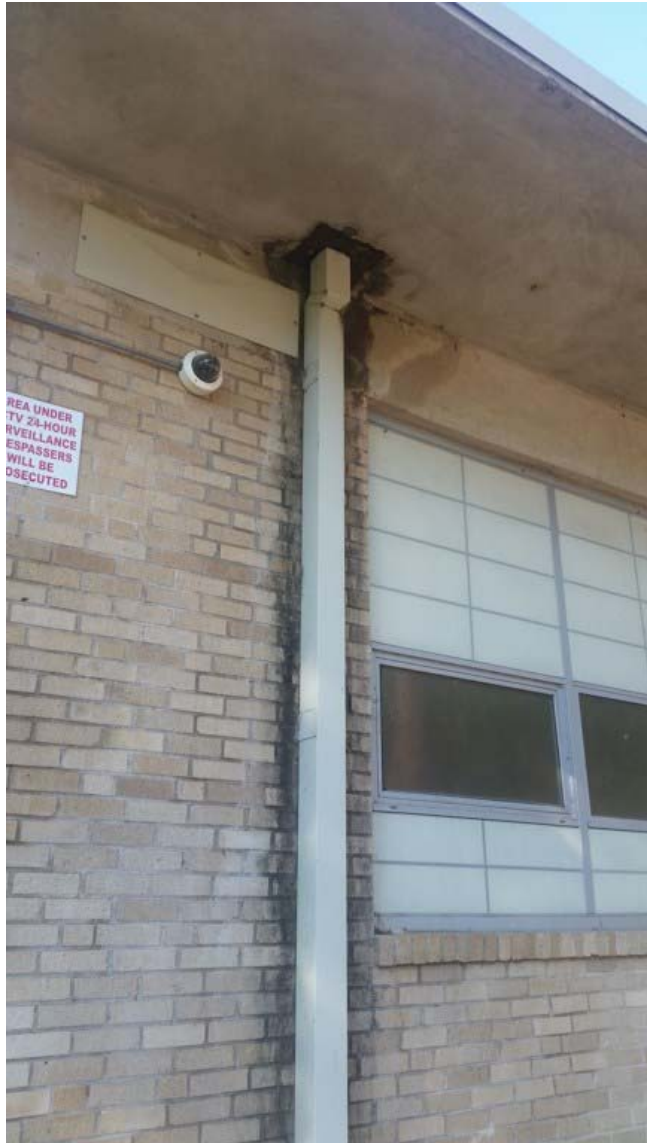
Roof leaks at gutters

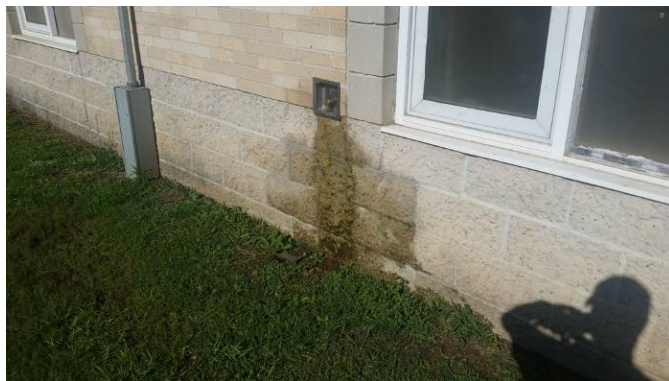
Faucet leak

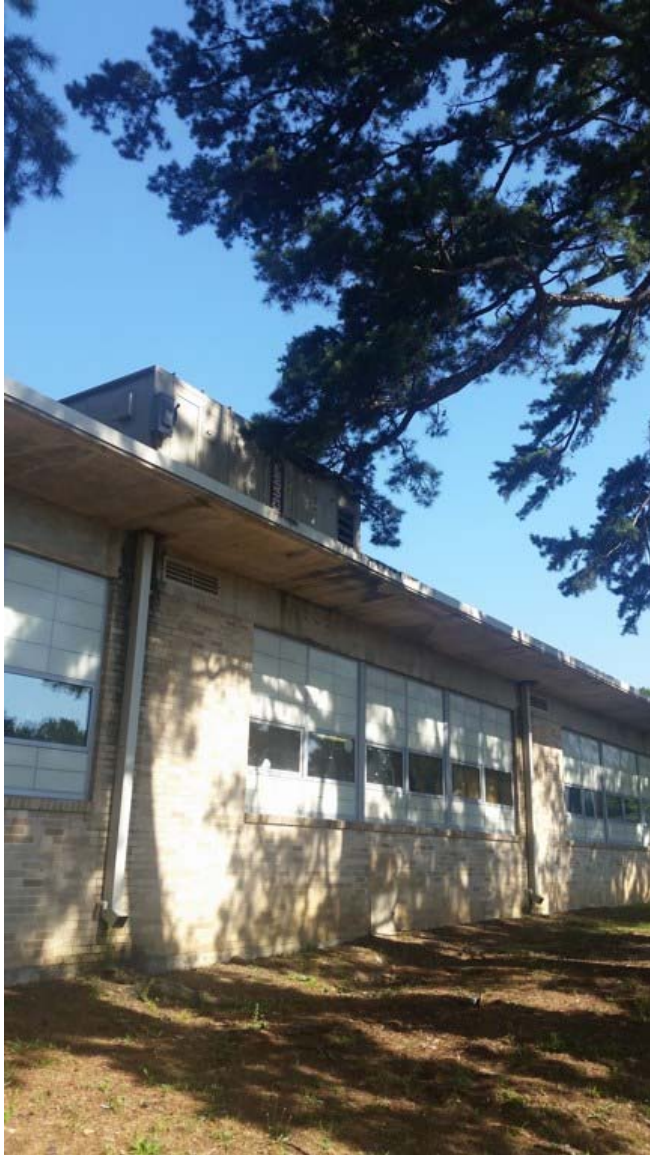
Roof leaks at soffit

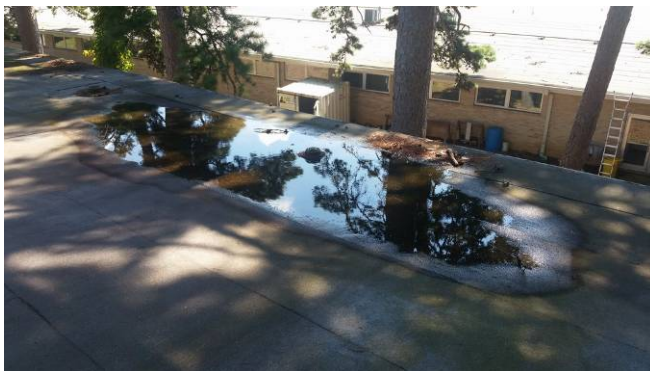
Example of ponding on roof

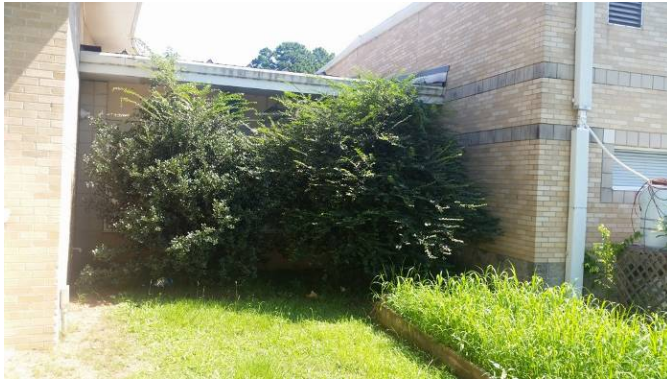
Overgrown bushes

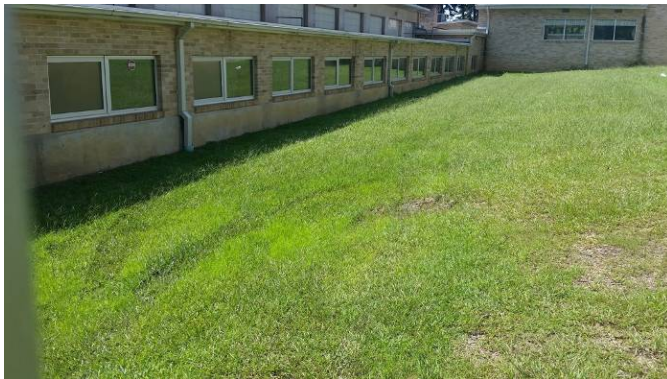
1. Vegetation needs to be trimmed away from the buildings and fences.
2. Poor grading in several areas causing some moisture intrusion into building. Lot generally slopes from W to E, the W walls of the wings are exposed to significant amounts of drainage during rainfall.

Slope of grounds is toward several buildings in areas

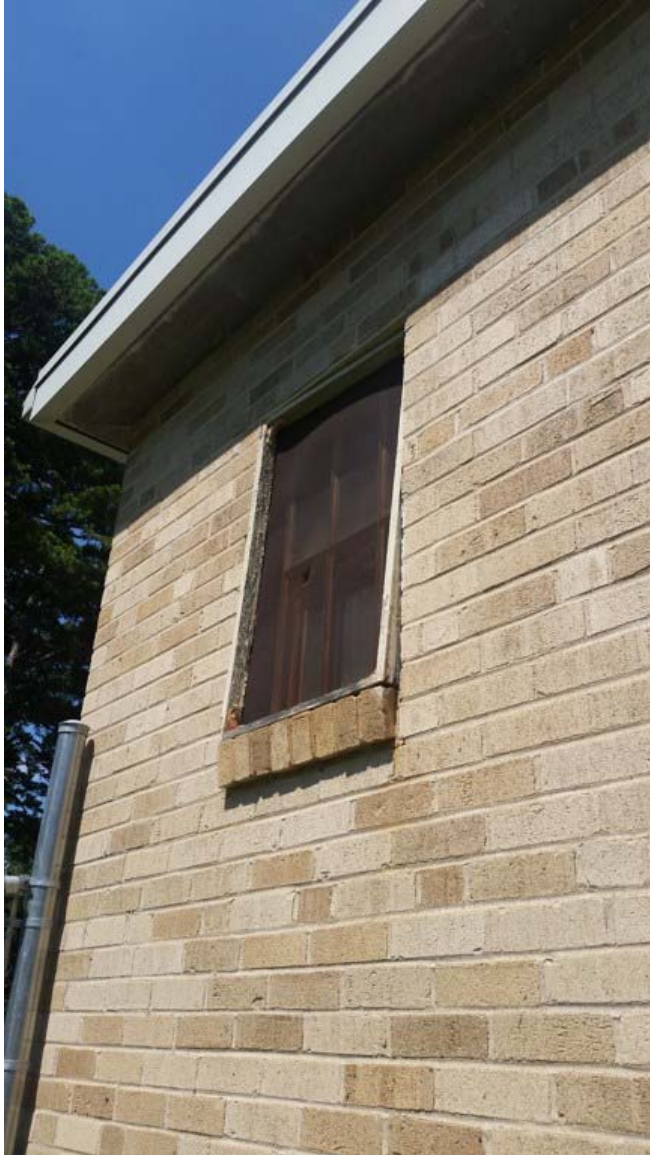
Brick pulling
